**Re: FIMLWA Dam Inspection
D.M. Wills Associates Project No. 5394**

D.M. Wills Associates ("Wills") was retained to complete a structural inspection of the concrete gravity dam located at the outlet (tributary to Hardwood Creek and the Napanee River) of Fourteen Island Lake in the Township of South Frontenac. The inspection was completed by Mr. David Bonsall, P.Eng. on November 11, 2020.

FOURTEEN ISLAND LAKE DAM		
EXISTING GENERAL ARRANGEMENT		SHEET SK-01

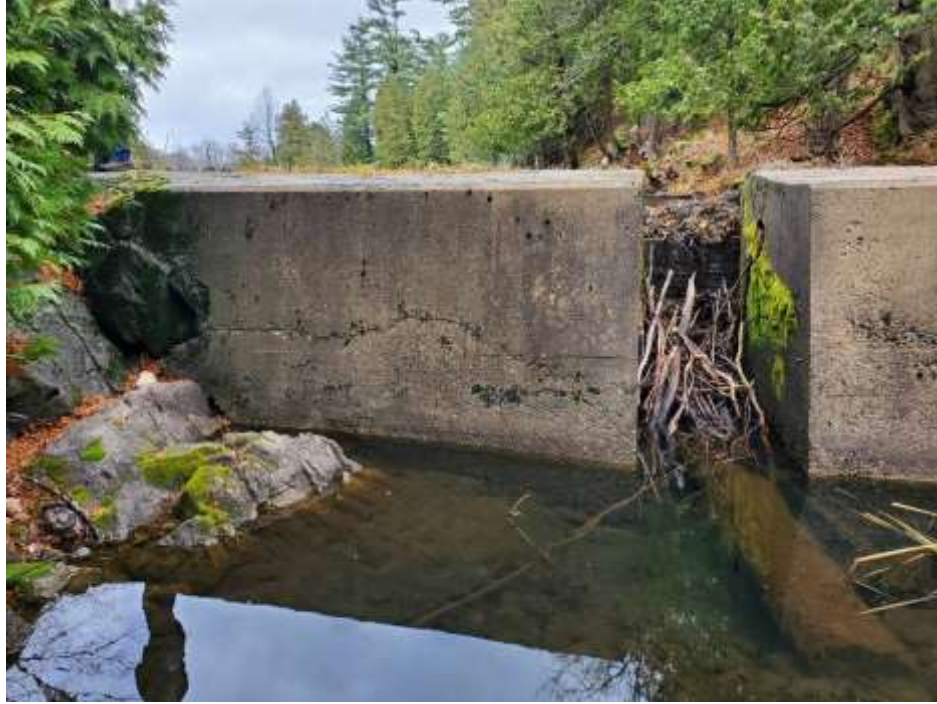
PHOTO#1 – Downstream Face (West Half)

The dam appears to be of rock core construction with a concrete "skin"; refer to Photo #1 and #2 for illustration of the downstream face of the dam (west and east "sides", respectively). The downstream face was sounded with a hammer and all concrete was in good condition with no delaminations or loose concrete.

Water depth in the upstream lake is controlled by timber boards contained within the gains. The timbers can be seen in Photo #1. The upstream sediment levels are very high and a large pile of debris (stick, branches, etc.) has been cast to the downstream, east side of the dam. Dam operations and future inspections would significantly benefit from removal of sediment and debris.

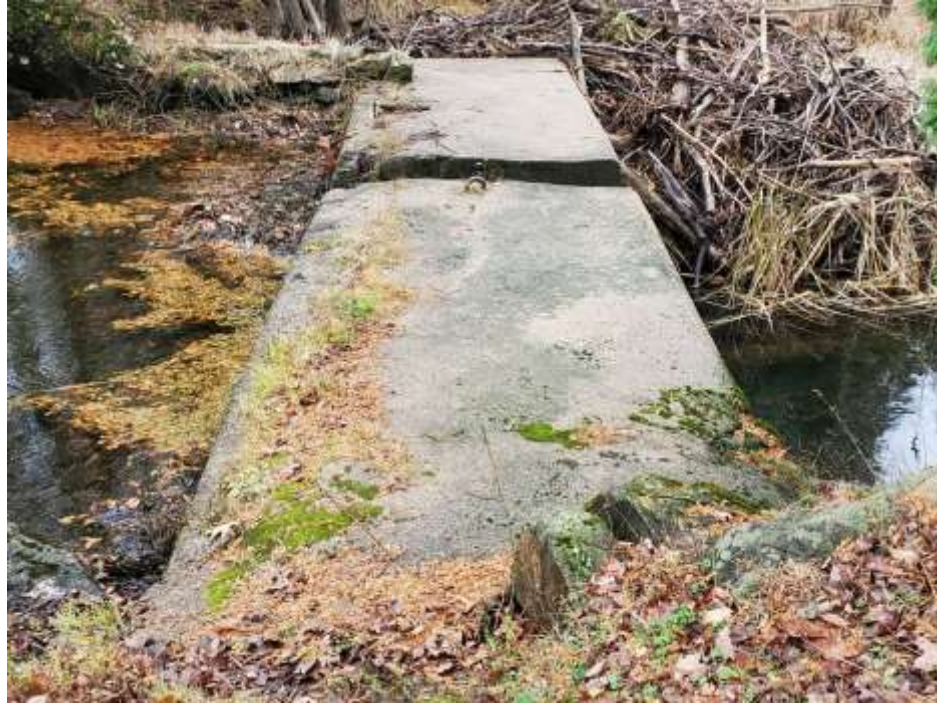
PHOTO#3 – Top of Dam (looking East)

The top surface of the dam, refer to Photo#3 and #4, is "L" shaped and is set into/against solid bedrock on each bank. No significant leakage was noted along the dam/rock interfaces. Significant deterioration was noted in the upstream half of the deck top in each "side" of the dam; refer to Photo #5 & #6. It appears that the dam may have been refaced in the past as there is a distinct formed line approx. 200mm (8") back from the upstream edge of the dam top. The line is now an open crack (line) that defines the upstream face from the deck top. The deck top against this line is in poor condition.

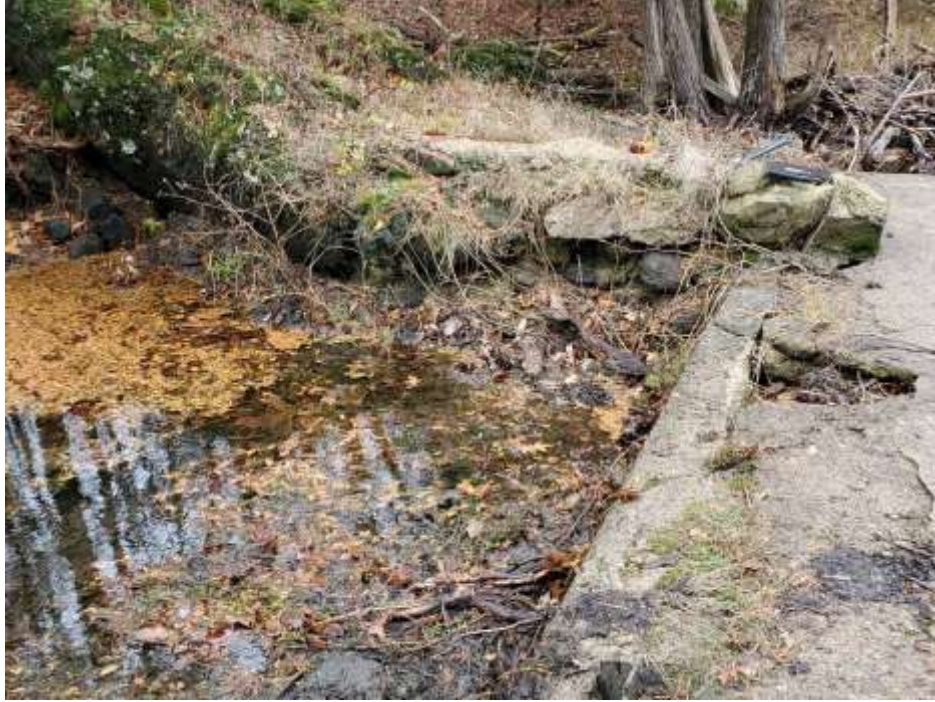
PHOTO#5 – Deck Top

The upstream face of the dam is mostly submerged and could not be inspected. The upper portion of the face (above the water line) is in fair to good condition, with several large vertical cracks. These cracks would allow water to penetrate into the core of the dam; however there was no obvious sign of water flowing through the dam structure. The cracks can be seen in Photos #5 and #6.

- Crack Injection (Repair) and Refacing of the Upstream Face;
- Removal and Replacement of the Top Slab;
- Removal and Replacement of the Gains and Sluice Walls;
- Installation of Drains in the Downstream Face.
