## **Final Report**

### **Scoped Dam Safety Assessment Fourteen Island Lake Dam**

**Township of South Frontenac, Ontario**

**D.M. Wills Project Number 20-5394**

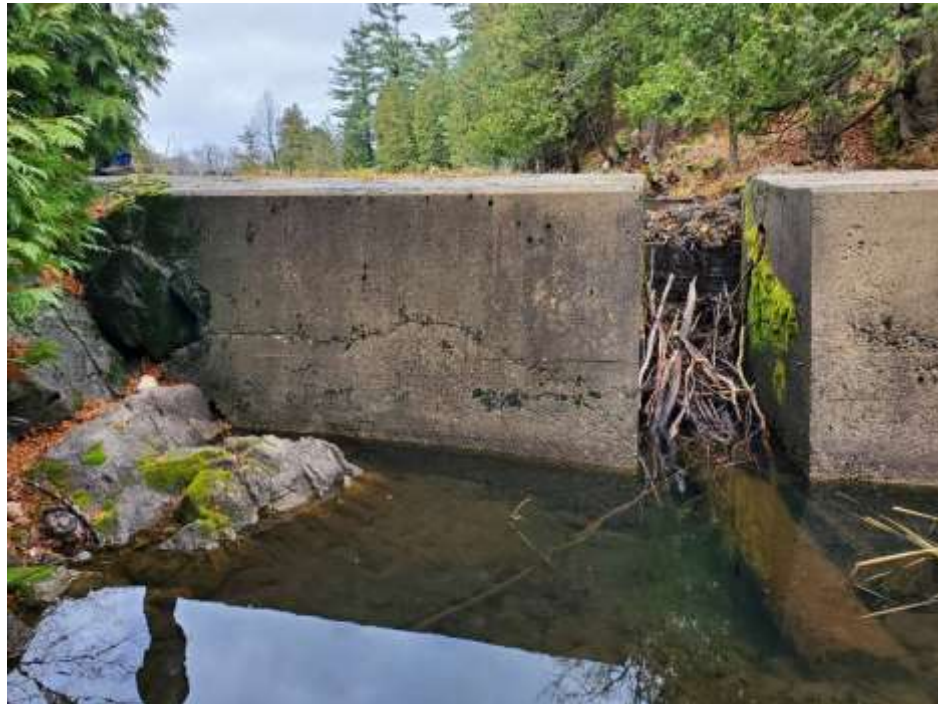
**PHOTO#1 – Downstream Face (West Half)**

The dam appears to be of rock core construction with a concrete "skin". The downstream face was sounded with a hammer and all concrete was in good condition with no delaminations or loose concrete. The top surface of the dam is "L" shaped and is set into/against solid bedrock on each bank. No significant leakage was noted along the dam/rock interfaces.

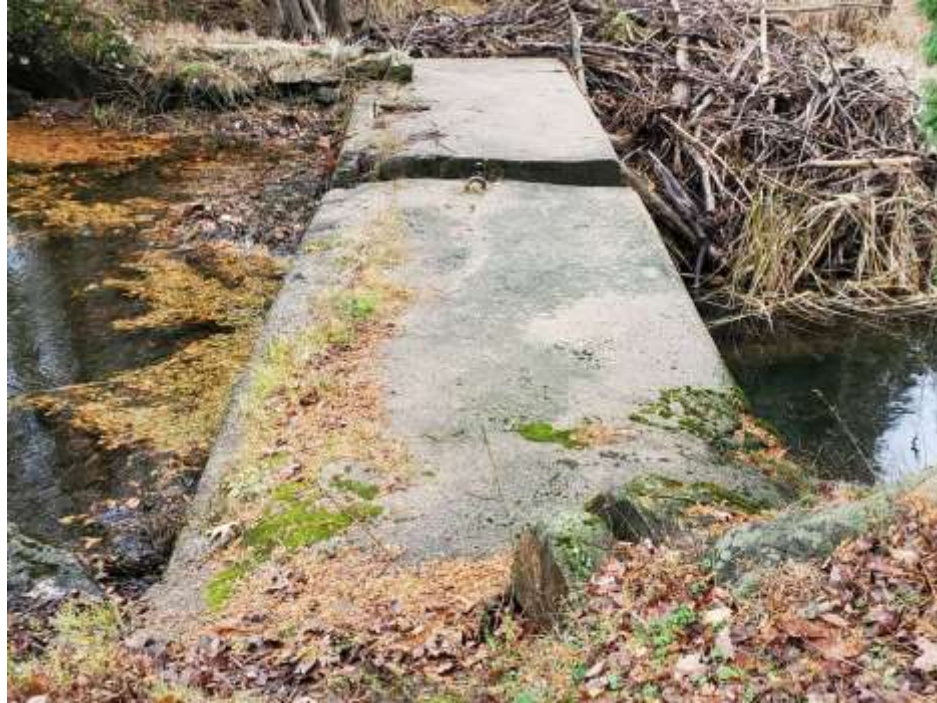
**PHOTO#3 – Top of Dam (looking East)**

Significant deterioration was noted in the upstream half of the deck top on each "side" of the dam. It appears that the dam may have been refaced in the past as there is a distinct formed line approximately 200 mm (8") back from the upstream edge of the dam top. The line is now an open crack (line) that defines the upstream face from the deck top. The deck top against this line is in poor condition.

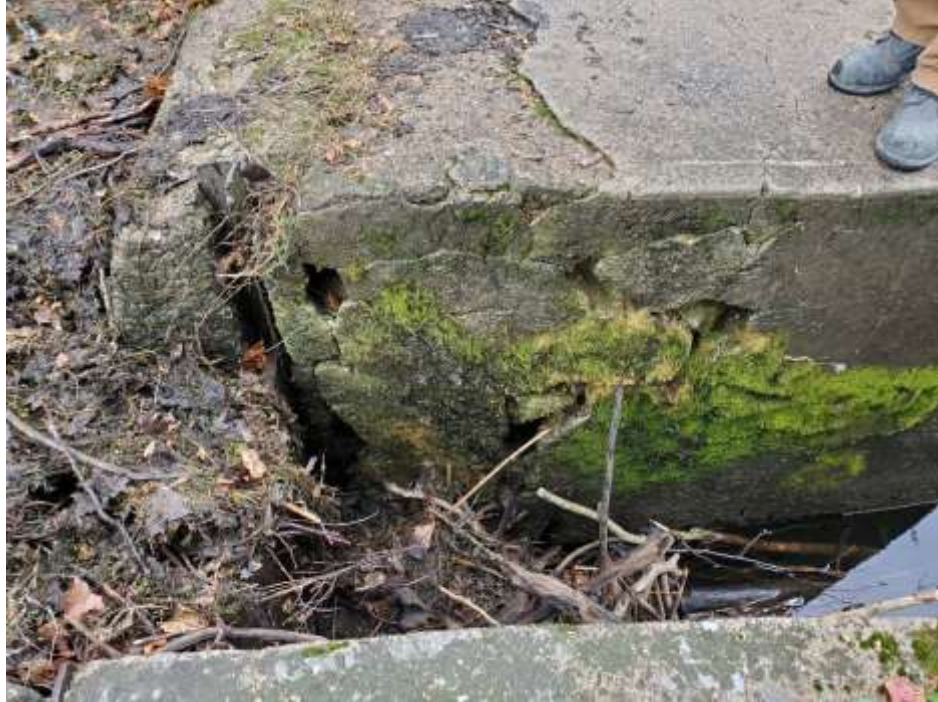
**PHOTO#7 – East Gain**

There are steel angles set into the concrete to form the operable gains for the dam. The steel angles are in generally good condition; however, the anchorage into the east portion of the dam is questionable. The concrete along the east side of the sluice (adjacent to and downstream of the gain) is in very poor condition. While no water was observed flowing from the core at the time of inspection, it is clear that water may build up in this area as ice in the winter and could cause significant damage.

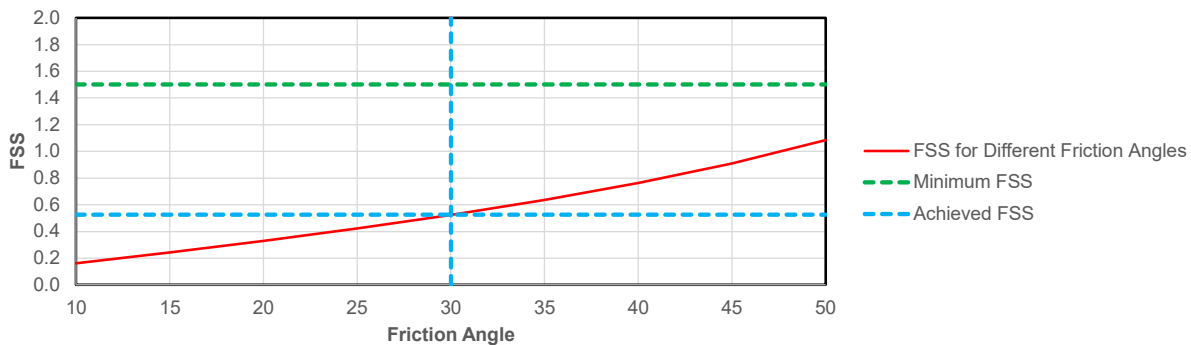
Factor of Safety Against Sliding = 0.52

Not Acceptable
