## **Final Report**

### **Scoped Dam Safety Assessment Fourteen Island Lake Dam**

**Township of South Frontenac, Ontario**

**D.M. Wills Project Number 20-5394**

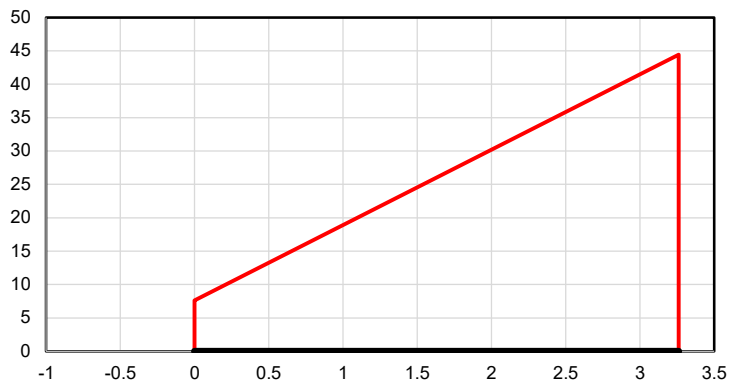
Normal Stresses Acting on Base (kN)

**Acceptable**

Principle Stress at Toe = 7607 N/m<sup>2</sup>

Principle Stress at Heel = 44444 N/m<sup>2</sup>
